# Horn Troubleshooting

## Ultrasonic Welding

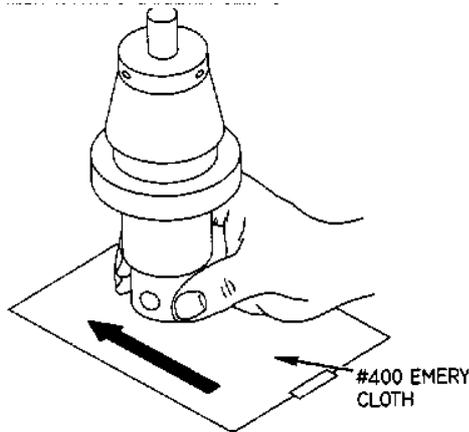
**IMPORTANT:** To maintain interface flatness, do not allow part to tilt when stroking. Do not apply downward pressure; the weight of the component is sufficient.

- a. Thumb over spanner wrench hole.
- b. Rotate the part 120 degrees (1/3) to the next hole.
- c. Provide equal number of strokes at each location (2 or 3).

6. Hold the part to be conditioned at its lower end and carefully stroke it *in one direction* across the emery cloth. (See illustration and instructions.) For best results, do not push down. Push the component gently.
